# SIKA AT WORK

PUKEKOHE TRAIN STATION,  
AUCKLAND, NEW ZEALAND

SEALING & BONDING · REFURBISHMENT

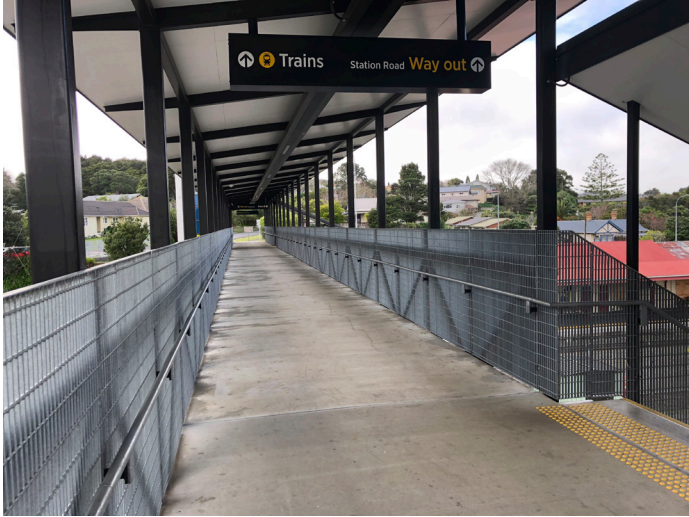
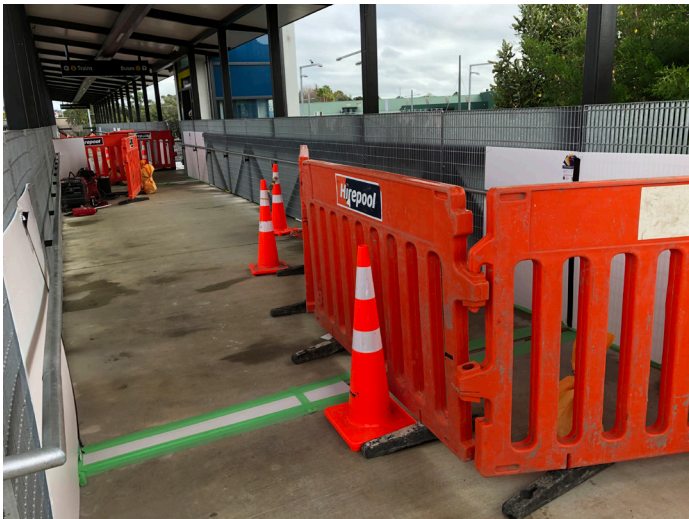
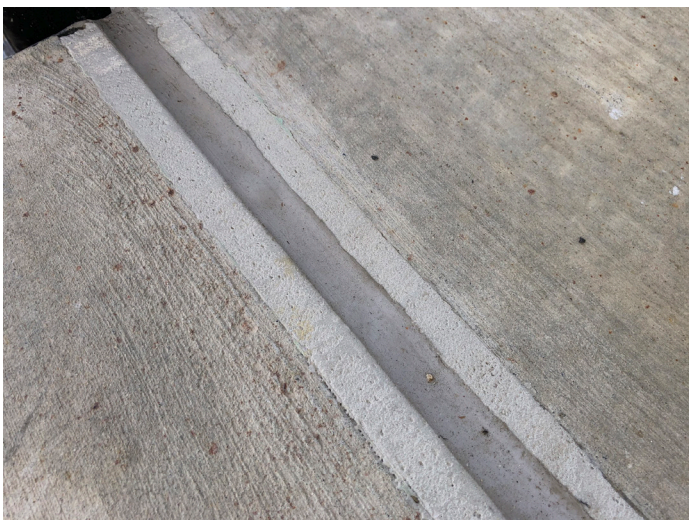
- The permanent steel shutters in place were making the existing sealant split
- The concrete edging against and over these steel shutters was break off
- The joints were leaking on the platform below and defective concrete edging could potentially become trip hazards.

Concrete repair solutions to reprofile joint edges, and the resealing of joints were required:

- The joint sealant needed to be tough to endure frequent pedestrian traffic (foot and trolley), along with flexibility to accommodate movement.
- Repairs to the concrete edging needed to be high strength and would bond to damp concrete as well as steel.

Sikadur-31 CF Normal  
Sikaflex PRO-3
