# SIKA AT WORK

## CHRISTCHURCH ARTS CENTRE, CHRISTCHURCH, NZ.

REAL LIFE TEST FOR SIKA STRUCTURAL STRENGTHENING SYSTEMS IN  
CHRISTCHURCH EARTHQUAKES

# CHRISTCHURCH ARTS CENTRE

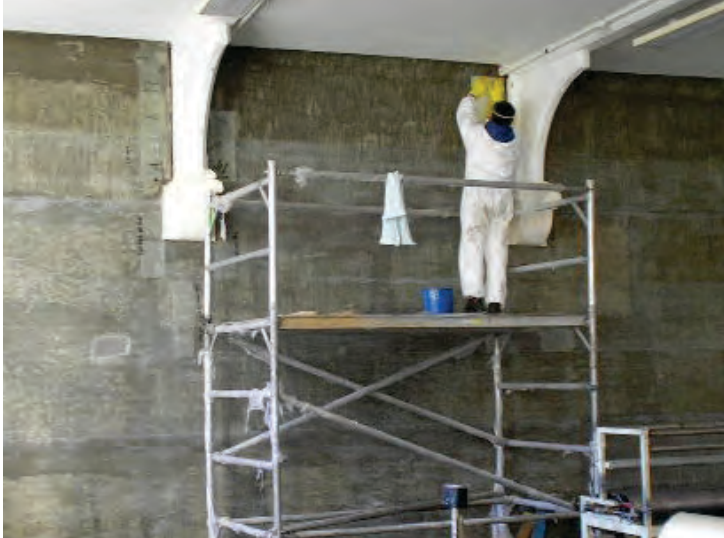
BBR Contech applied SikaWrap-100G fabric seismic strengthening to the historic Arts Centre buildings in Christchurch prior to the devastating earthquakes of 2010 and 2011.

After some rebuilding of the underlying original volcanic basalt stone walls, BBR Contech applied about 200m<sup>2</sup> of SikaWrap Unidirectional glass fibre fabric. The internal linings were then reinstated to return the rooms to near original condition, with no visible sign of the restoration work beneath.
