SIKA AT WORK

RE-ROOFING OF THE NATIONAL ARMY MEMORIAL MUSEUM, NZ

ROOFING: Sarnafil® S327-20 L · Sika® UniBase · Sikalastic®-621 TC

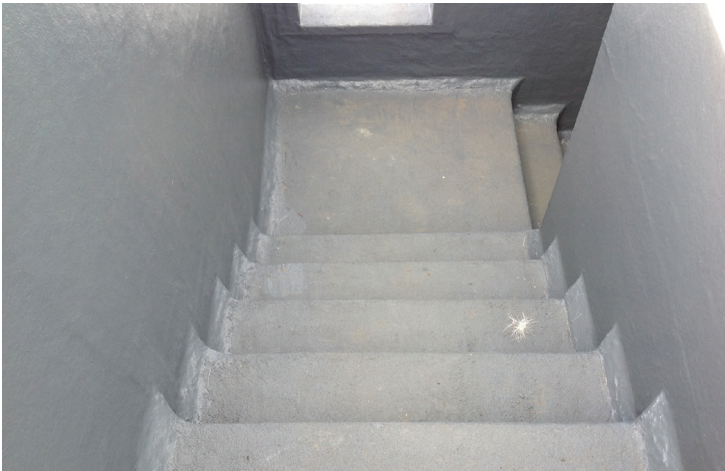
Sikalastic-621 TC, part of the SikaRoof MTC System has been used to waterproof the stairwell.

SikaRoof MTC was used on the guttering (200m²) and also used to waterproof the walls of the stairwell and the treads of the stairs. An additional layer of **Sikalastic-621 TC** was installed with an aggregate cast into it, providing required slip resistance.

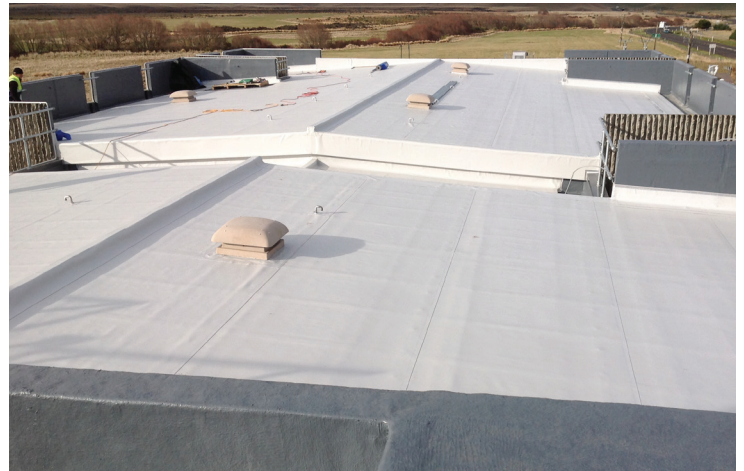
Sarnafil and SikaRoof MTC systems on the Museum's roof.

Sika Sarnafil and **SikaRoof MTC Systems** were the solution for the leaky roof. **Sarnafil S327-20 L** was installed through the existing membranes (1000m²) and into the timber purlins of the roof structure.
