## WELLSFORD PRIMARY SCHOOL

WATERPROOFING: SIKASIL POOL

# WELLSFORD PRIMARY SCHOOL, AUCKLAND, NZ.

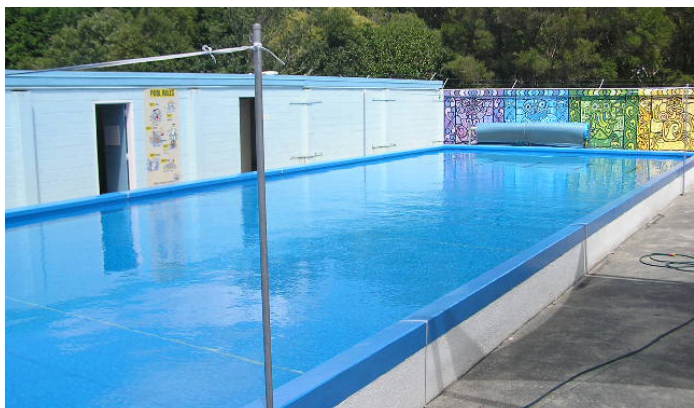
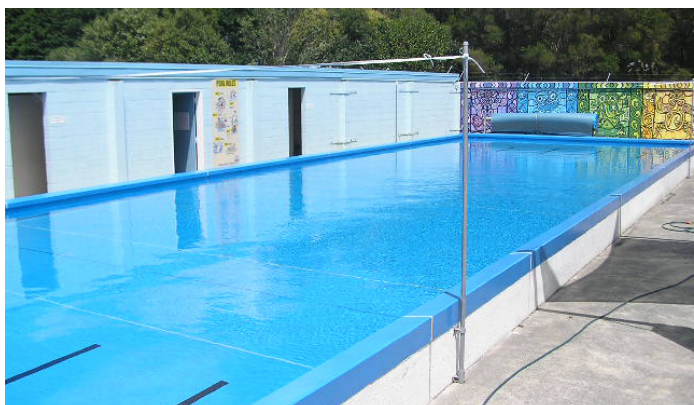
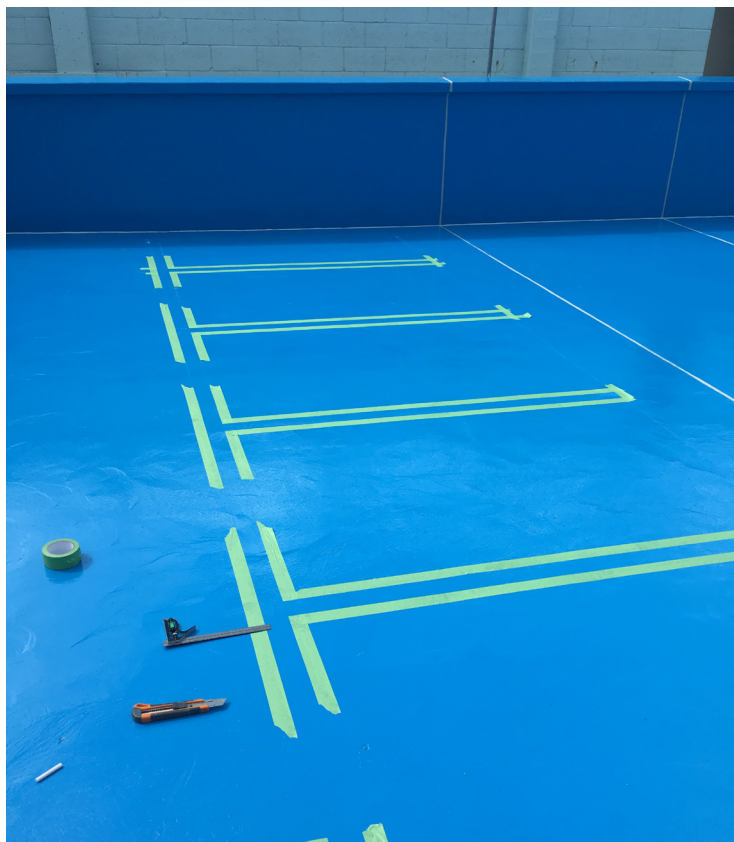
A visual inspection of the Wellsford School swimming pool confirmed the leaks were from the existing joint sealant. This had to be removed and cleaned before new Sika joint sealant could be applied. The installation was done in three phases:

The school pool had been upgraded the year before by a company that had incorrectly fixed the joints. The sealant they used failed, to bond, causing the pool to leak so much it needed to be refilled every week.

- PEF Rod inserted into the joints to prevent three sided adhesion
- The surface of the concrete was primed using Sika Primer<sup>®</sup>-3 N
- Sikasil<sup>®</sup> Pool was applied in accordance with the Sika product data sheet
