REFURBISHMENT STRUCTURAL STRENGTHENING WITH SIKA SYSTEMS

FOR OWNERS OF BUILDINGS AND CIVIL ENGINEERING STRUCTURES

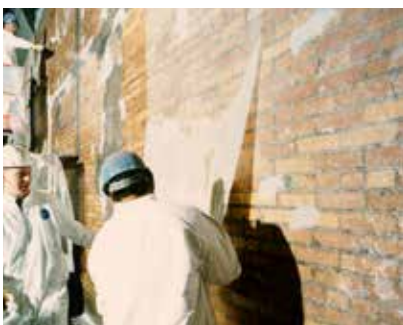
SEISMIC UPGRADING /EARTHQUAKE DAMAGE REPAIR

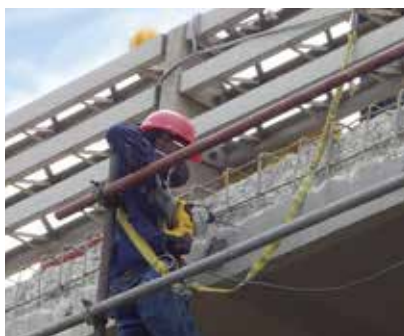
Substrate preparation

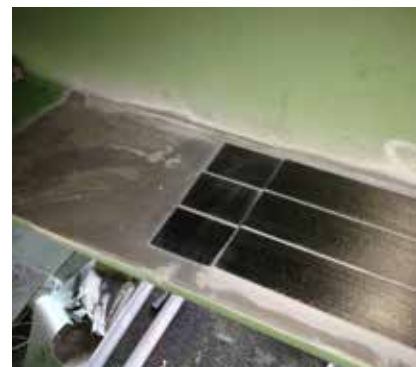
Two layers of Sika CarboDur®

CarboDur® system. After the steel substrate was cleaned and prepared by abrasive blast cleaning, the prefabricated CarboDur® CFRP plates were then immediately bonded to the steel surface with Sikadur® structural adhesive. With these strengthening measures, the mechanical characteristics of the structure were increased and the amplitudes of stresses due to movement were reduced; thus the service life of the bridge was significantly extended. This was the first experience in France of strengthening this type of structure with bonded CFRP.

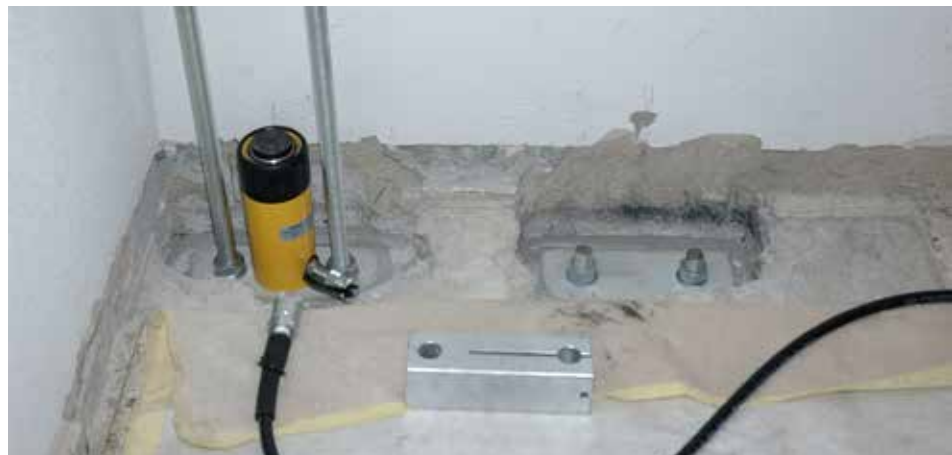
Pressure cylinder
