SIKA AT WORK

REHABILITATION OF THE OHIO MISSOURI HISTORIC BRIDGE FLORIDA, U.S.A.

STRENGTHENING: Sika Carbodur® BC Rods

REHABILITATION OF THE OHIO MISSOURI HISTORIC BRIDGE

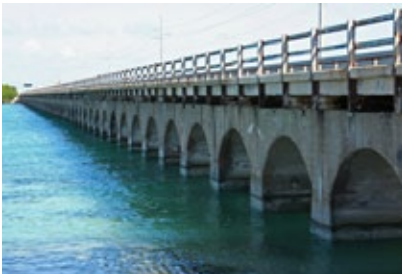
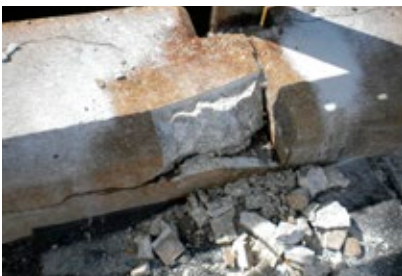
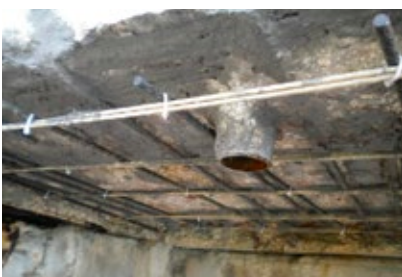
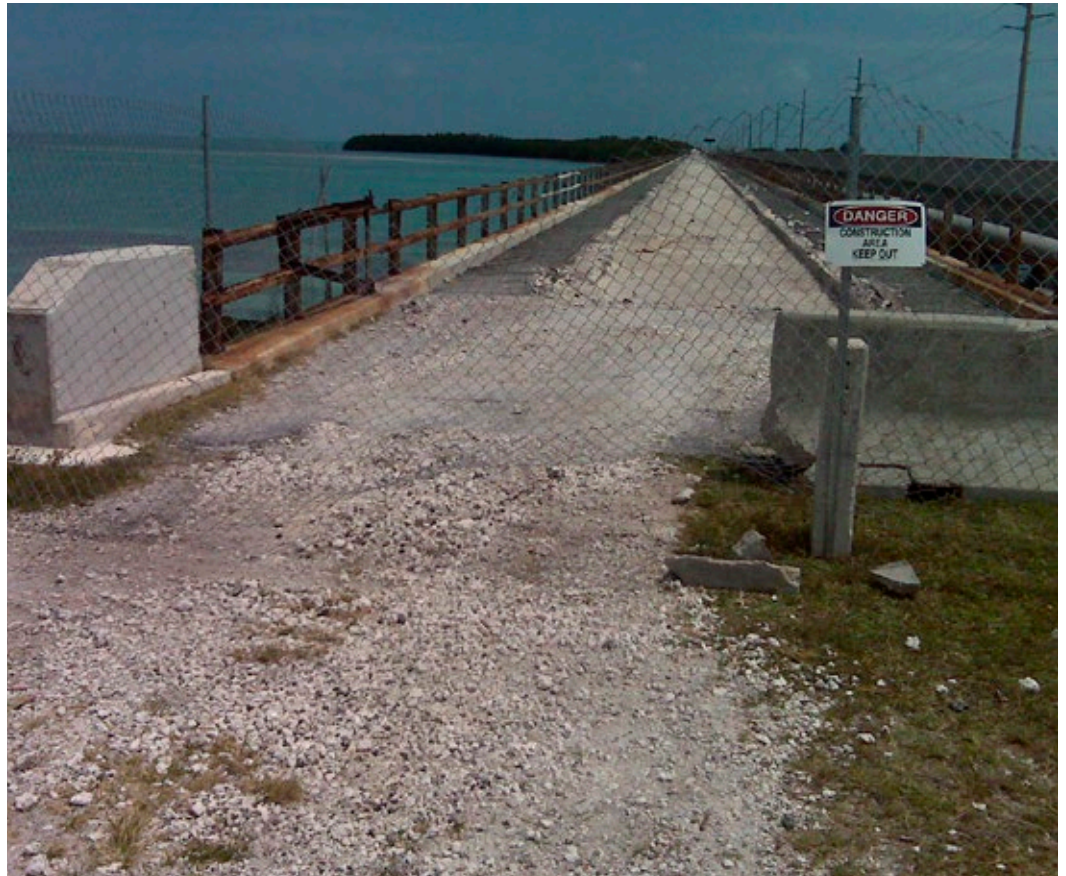
During the conversion of the structures from train to vehicular use, the existing lanes had to be widened. Cantilever sections were added to the in-place structure to extend the width of the bridge. The main structural members were partially exposed steel H beams. Because the structure is located in a very aggressive coastal environment and subjected to salt water ingress and the wrath of severe storms, the steel H beams showed signs of corrosion and it became apparent that the integrity of the structure had been compromised.

The repair strategy was to use a non-corrosive structural strengthening method with minimal impact to the environment.

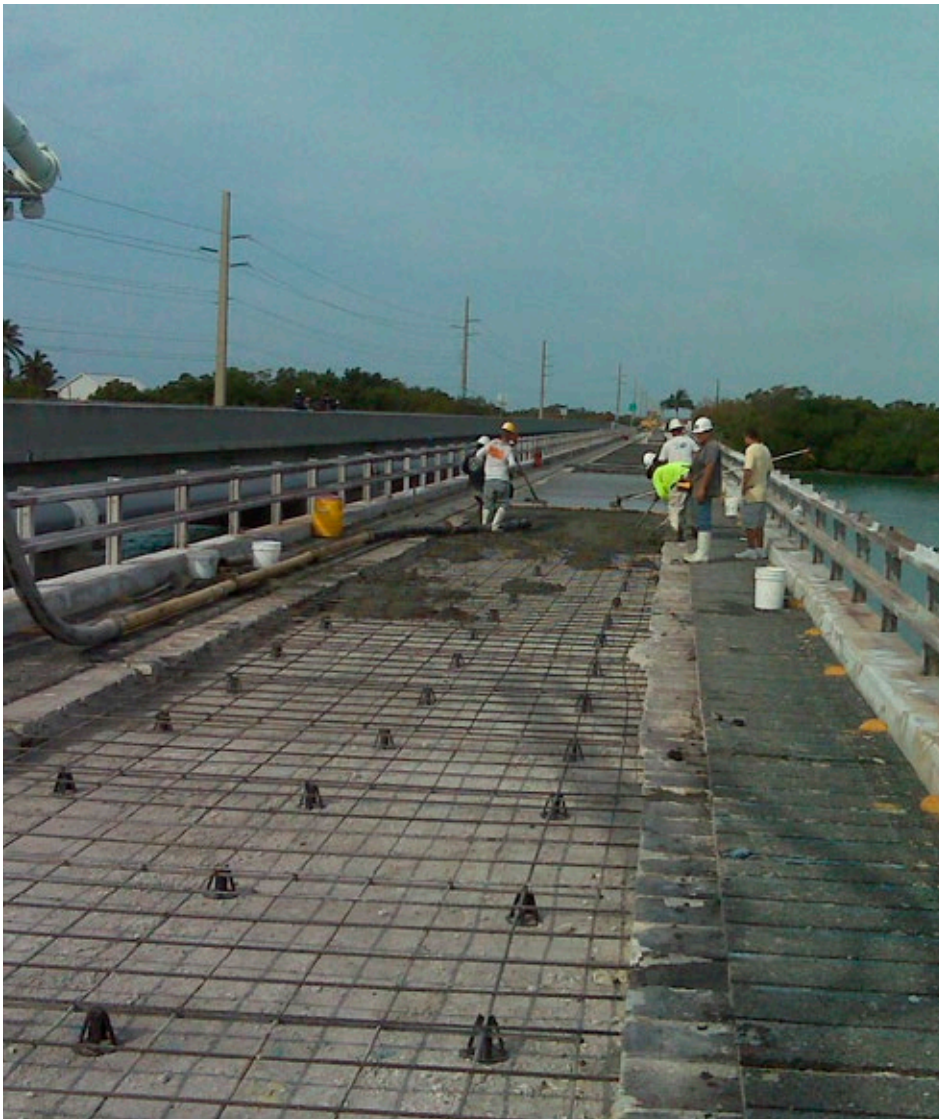
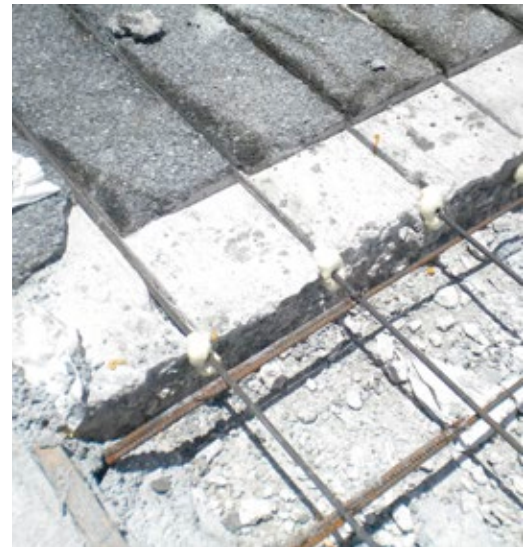
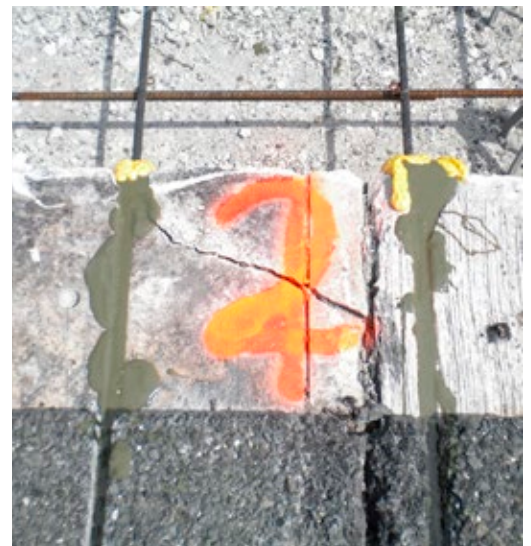
In addition to the potential environmental impact, the historical significance of the cantilevered sections would have been lost. The installation of the carbon fiber rods into the deck provided alternative support for the deteriorated H-beams in the cantilevered additions used to widen the bridge. This eliminated the intrusive and environmentally damaging effects of demolishing the cantilevered sections.

Sika® Carbodur® BC Rods were used in the spall repairs of the undersides of the severely damaged cantilevered sections. These were used to replace the small reinforcing bars that had been part of the original construction. The existing steel beams were not restored because some had experienced extensive section loss, while others were missing completely. The carbon fiber rods installed in the deck were designed to replace the support these H-beams had been providing. Structures such as the Ohio Missouri Historic Bridge are truly a classic example of sustainable concrete structures that have not only outlived their designed service life but continue to serve the community with a new and more beneficial purpose than originally intended.
