# SIKA AT WORK

## 75 QUEEN STREET, AUCKLAND, NEW ZEALAND

### REFURBISHMENT

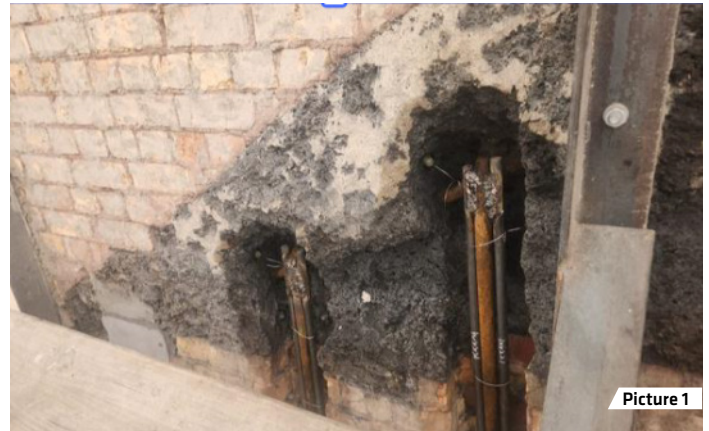
Picture 1: Deteriorated concrete was broken out to expose reinforcement, with Sika FerroGard® Patch anodes incorporated to help prevent future corrosion.

Sika FerroGard Patch anodes were installed to help mitigate further corrosion and extend the service life of the reinforcing steel. Damaged concrete was then removed and reinstated using Sika MonoTop-438 R, restoring the structural integrity and durability of the building while maintaining its original form.

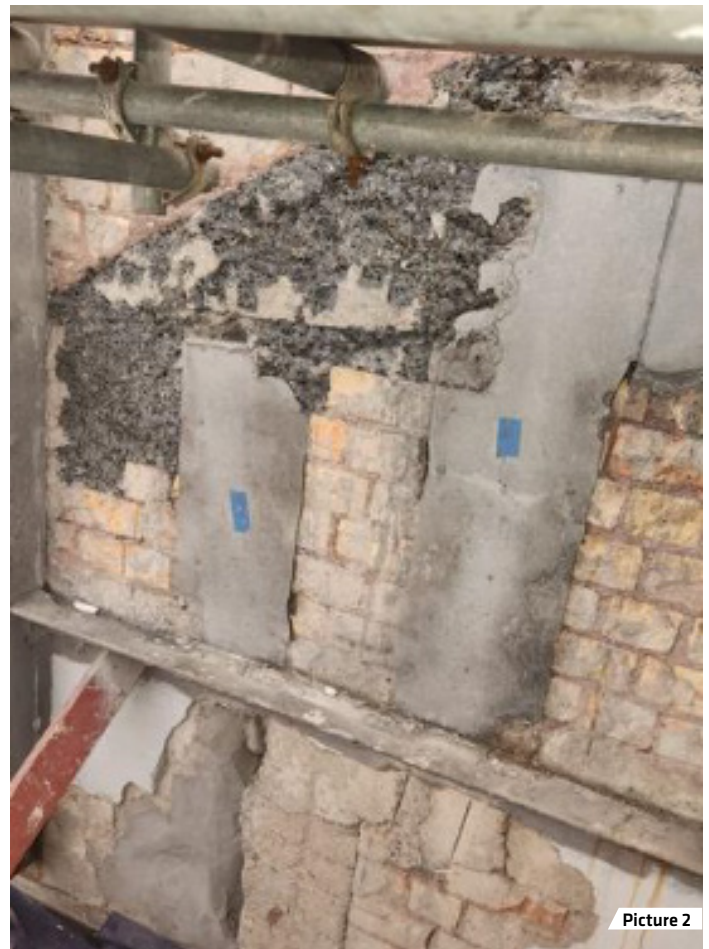
Picture 2: The repair was completed using Sika MonoTop®-438 R, with the formwork removed to reveal the reinstated concrete surface and restored structural profile.
