# SIKA AT WORK

## MARINO APARTMENTS, AUCKLAND, NEW ZEALAND

REFURBISHMENT

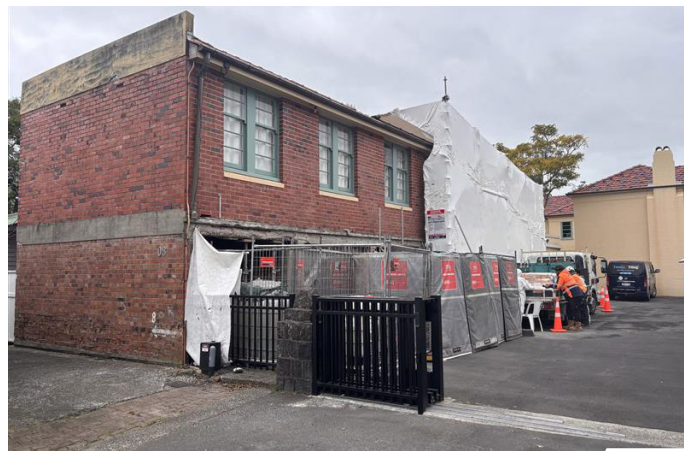
Picture 2

Picture 2: Scaffolding installed around the building exterior to facilitate structural remediation works.

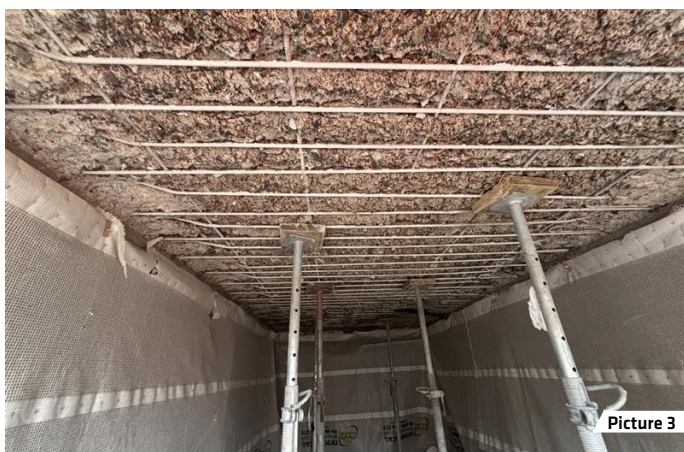
Picture 3

Picture 3: Reinforcement exposed and prepared for concrete repair following the removal of deteriorated and damaged material.

The Marino Gardens refurbishment required the repair of deteriorated overhead concrete within a heritage building. The repair should restore durability, extend the building's service life, and preserve its historic character.

A key challenge of the project was undertaking extensive overhead concrete repairs within the heritage building. The work required specialised application methods, careful access management, and measures to preserve the building's historic character while minimising disruption to residents.

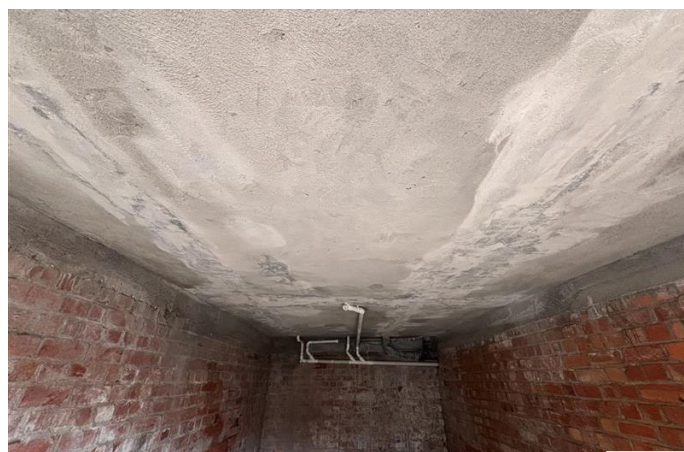
Picture 4

Picture 4: Completed concrete repair and resurfacing works using Sikacrete® Gunit-103.

Sika provided a durable concrete repair solution for the Marino Gardens heritage building using Sikacrete® Gunit-103, a spray-applied repair mortar designed for overhead and vertical concrete remediation. The system enabled extensive overhead concrete repairs to be completed safely and effectively while maintaining the building's structural integrity.

Approximately 430 bags of Sikacrete® Gunit-103 were used to restore deteriorated concrete, delivering a long-lasting repair solution that supported the preservation and ongoing protection of this significant heritage asset.
