SIKA AT WORK

HOUSE RUSSELL, PARNELL, AUCKLAND, NEW ZEALAND

ROOFING

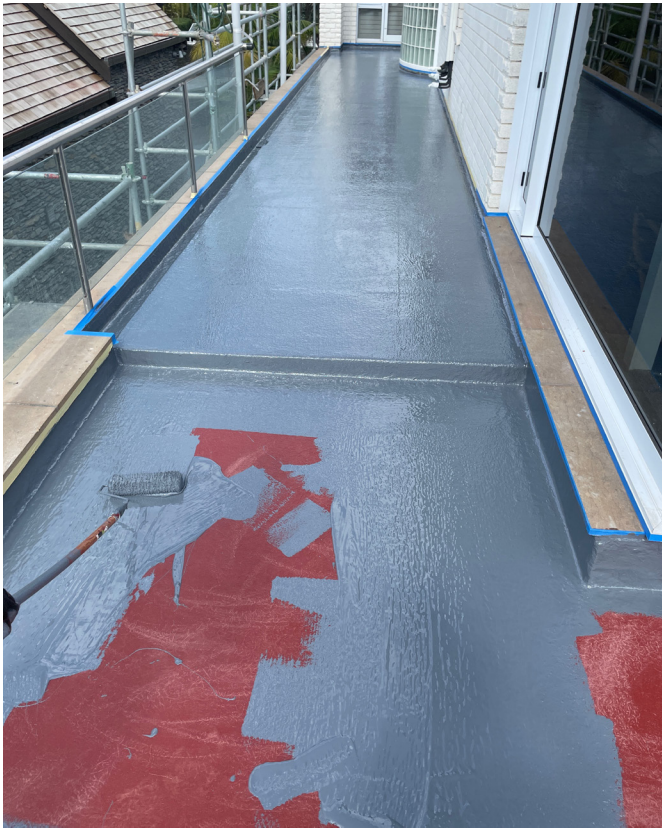
SikaRoof® i-Cure's top coat (Sikalastic®-641) been applied over the system base coat (Sikalastic®-631). East side of house.

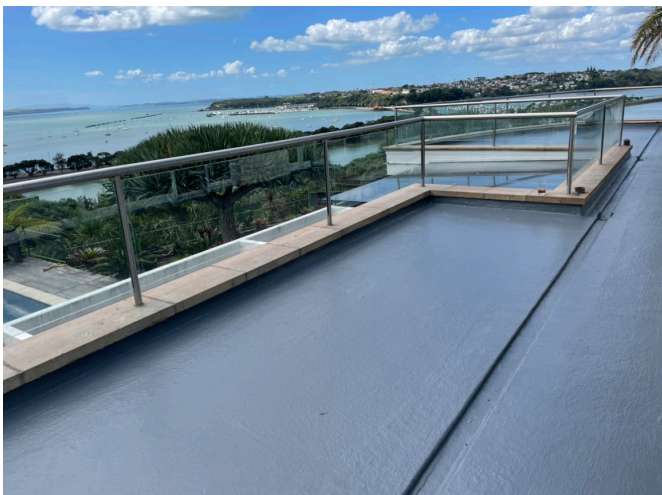
SikaRoof® i-Cure-22 system applied over SikaScreed®-1 on concrete balcony deck over habitable space below.

The project entailed addressing a leaking balcony deck situated over a habitable space. The existing waterproofing system was stripped back to the concrete deck due to its irreparable condition. SikaScreed®-1 was used to establish proper falls and ensure efficient water drainage. The SikaRoof® i-Cure-22 system, applied over the prepared surface, provided a durable and seamless waterproofing solution. Notably, this liquid-applied system was selected because it could be applied over existing membranes. By combining SikaScreed®-1 for correct falls and the application of SikaRoof® i-Cure-22, the project achieved functional and long-lasting waterproofing, successfully meeting the client's requirements for a watertight balcony deck over a habitable space.

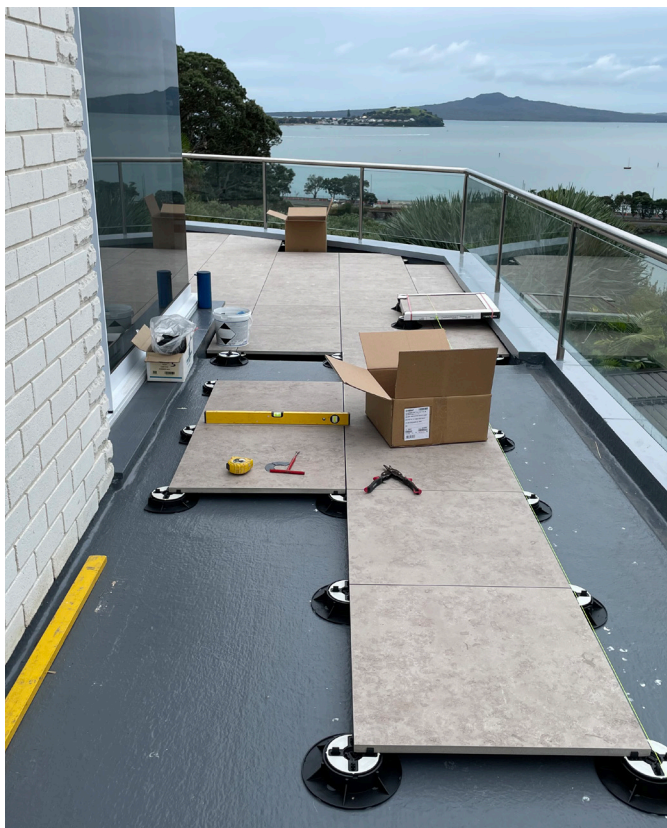
Tiling on pedestals being installed over the SikaRoof® i-Cure-22 system. East side of house.

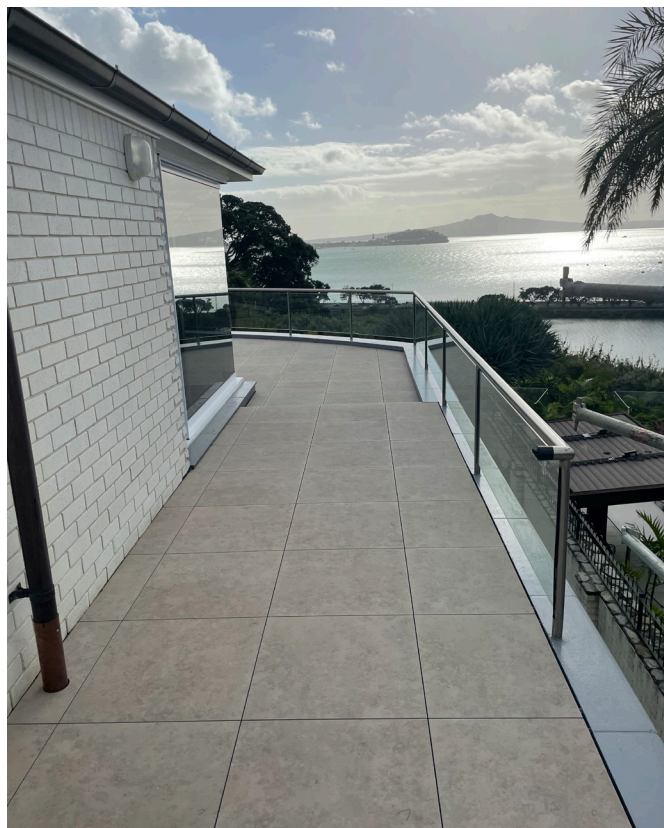
End result - East side of house.

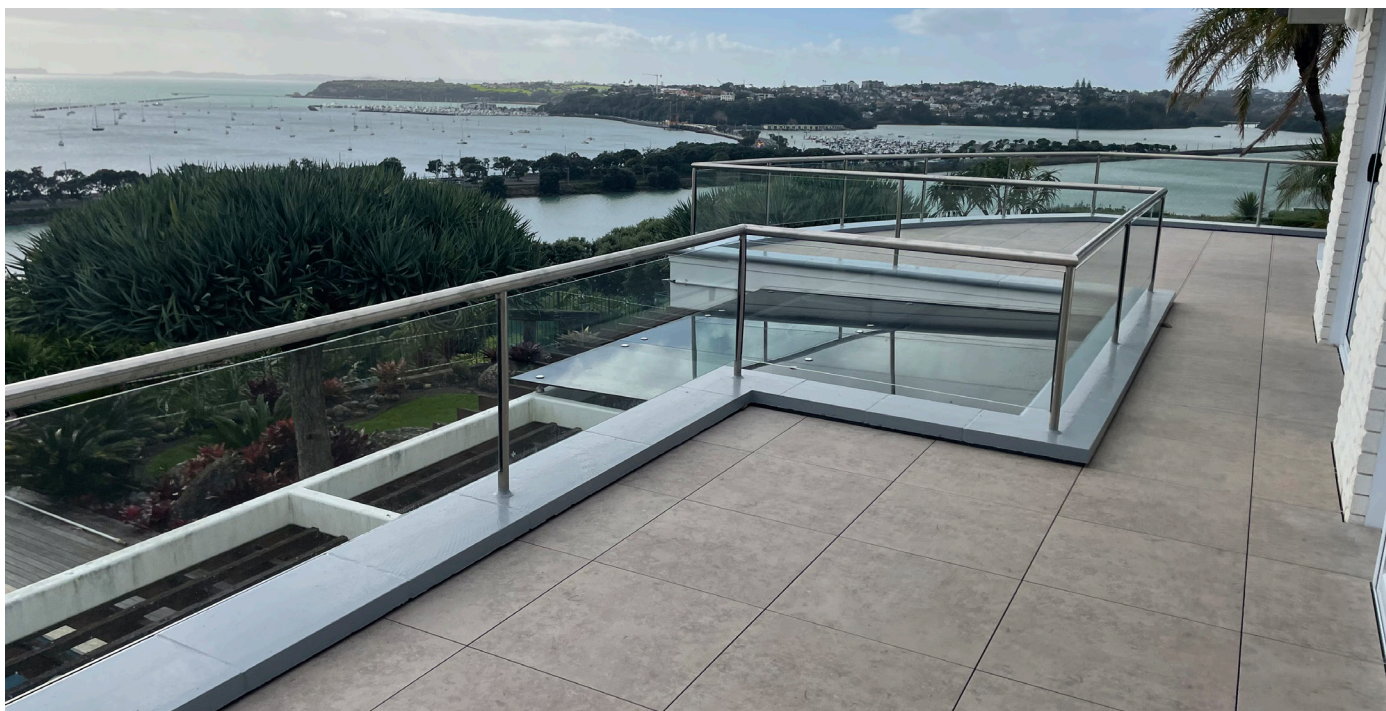
Finished deck with tiling on pedestals over the SikaRoof® i-Cure-22 system.
