SIKA AT WORK 61 THORNDON QUAY, WELLINGTON.

QUAKE STRENGTHENING A HERITAGE BUILDING USING SikaWrap®

61 THORNDON QUAY, WELLINGTON

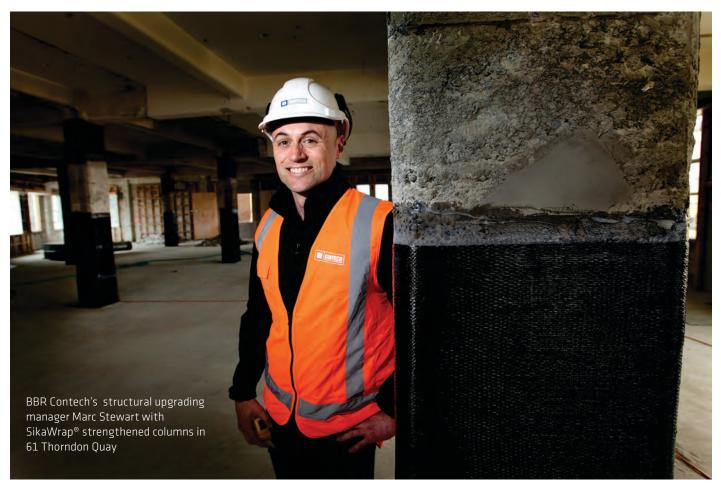
Now, steel is often replaced with a carbon-fibre weave called SikaWrap which is wrapped around columns and held in place with epoxy glue. SikaWrap works in the same way as steel, by allowing the column to move with the quake, absorb its energy and dissipate it.

BBR Contech, installed SikaWrap on four floors of 61 Thorndon Quay. It will also be used on some of the ceiling beams, which need work after the interior is remodelled. The wrap can also be inserted into unreinforced masonry, or used on the exterior of a building and covered with facade - enabling building owners to add strengthening while still keeping the heritage.
