SIKA AT WORK

CENTREPLACE NORTH, BRYCE ST,
HAMILTON, NEW ZEALAND

FLOORING

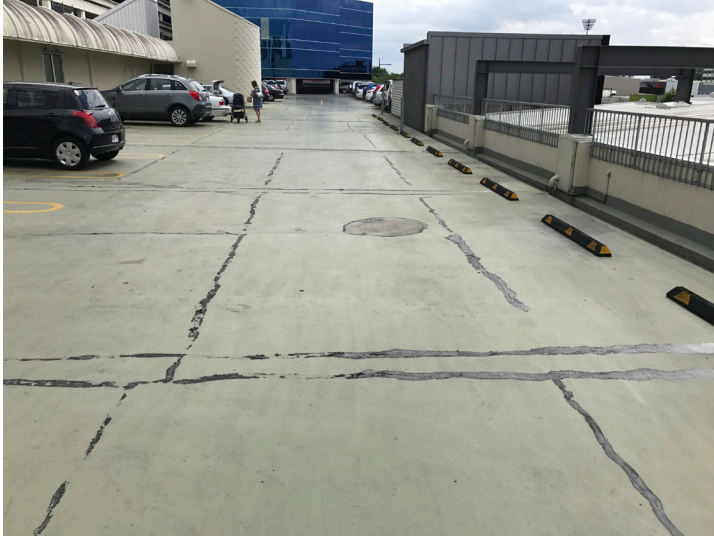
Before

Kiwi Property had been having ongoing issues with the integrity and weather tightness of the car park deck finishes at Centreplace North. Previous systems failed to meet the demands of:

- Full weather exposure to the north face
- High traffic flow
- Bridging to cracks and joints

- Many cracks were reflecting through the existing system and previous joint solutions had failed.
- Access for equipment and product delivery required early morning road closures. (One key advantage of our Car Park Deck System is that it does not add significant weight to the structure and no heavy plant or equipment is required for the installation.)
- The system needed to be highly durable to accommodate the significant traffic flow and high mechanical stresses.

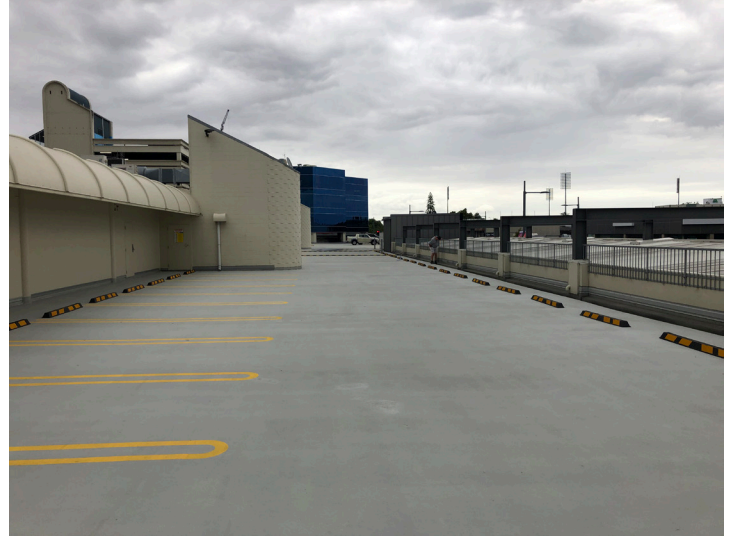
After

Sika was asked to provide a trafficable, waterproof membrane for a fully exposed exterior car park deck over retail spaces. In addition, joint sealing solutions were required for cracks, control joints and seismic joints.

Sikafloor®-156
Sikafloor®-350 N
Sikafloor®-375
Sikafloor®-359
Sika Aggregates
Sikadur® Combiflex-SG System
Sikaflex® Tank N
